# WILDLIFE CROSSINGS PLAN

**DURHAM-CHAPEL HILL-CARRBORO  
METROPOLITAN PLANNING ORGANIZATION**

**2024**

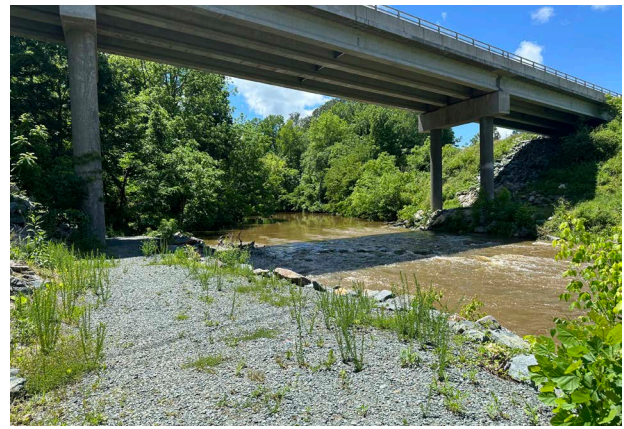
Figure 2.3.1.2: Photograph of US 70 bridge over the Eno River. DCHC MPO.

The wildlife crossing along US 70 over the Eno River in Orange County (Figure 2.3.1.2) is an example of a transportation project in the MPO's planning area that eliminated this type of obstacle by repositioning riprap to create a wildlife bench. When this type of mitigation measure is implemented in new projects such

as a bridge installation or replacement from the start, the cost to position riprap as to not impede wildlife movement is minimal, as is the cost needed for finer material placed over the top of the riprap.

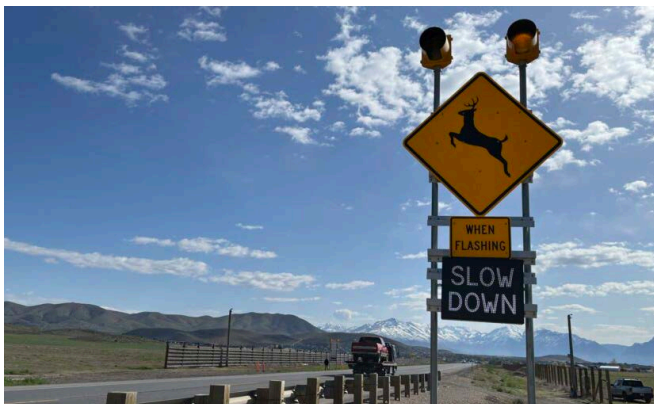
Figure 2.3.1.8: Flashing beacon for wildlife crossings in Utah. Adam Small, KSL NewsRadio.

*Flashing beacons* have been proven to be more effective at gaining drivers’ attention and reducing vehicular speed. These activated wildlife crossing signs are typically installed during seasonal migration periods and are equipped with flashing lights to attract driver’s

attention. Activated signs can use infrared technology to detect approaching wildlife, which will trigger the flashing lights,<sup>36</sup> or the lights can be set to remain flashing for a set period of time. A study conducted by the Insurance Institute for Highway Safety found that flashing beacon signs reduced speed by 8 mph, and that DVCs were reduced by 70% during migration.<sup>37</sup> The NCDOT Division Traffic Engineer should be contacted when requesting flashing beacons.

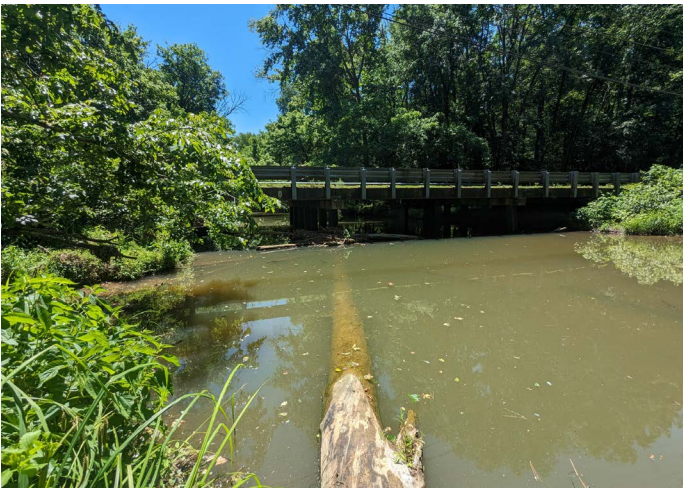
East side of Jones Ferry Road bridge over Neville Creek. Pete Schubert.

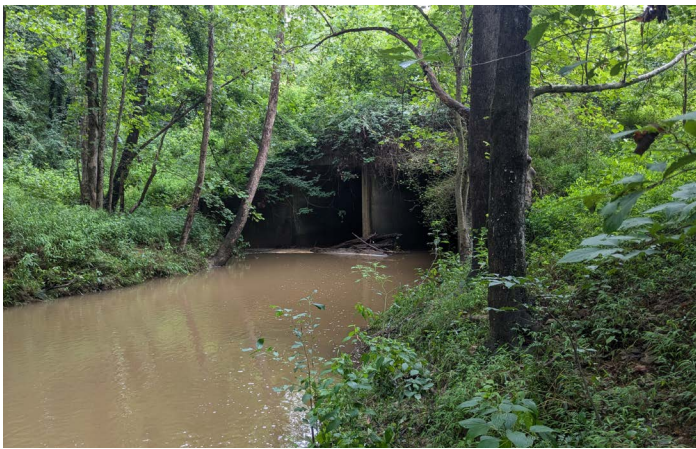
North side of NC 54 culvert, facing South.  
Pete Schubert.

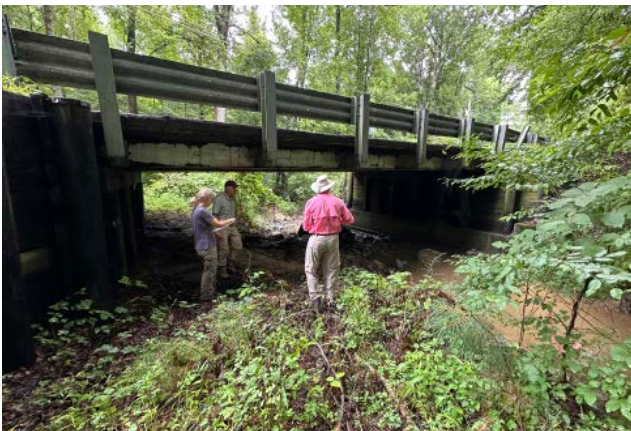
West side of Damascus Church Road bridge over Pritchard Mill Creek, facing east. DCHC MPO.
