WILDLIFE CROSSINGS PLAN

**DURHAM-CHAPEL HILL-CARRBORO
METROPOLITAN PLANNING ORGANIZATION**

October 28, 2024

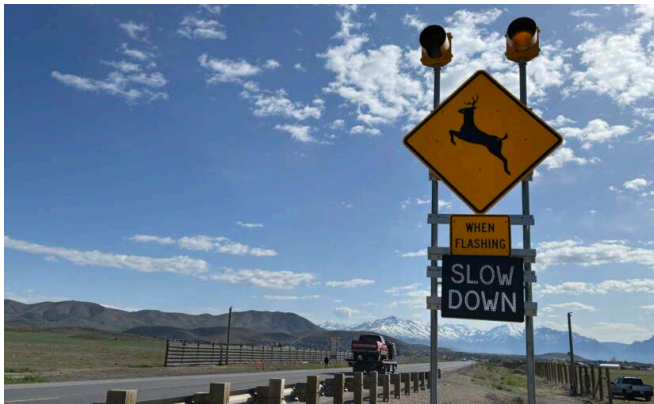
Figure 2.3.1.8: Flashing beacon for wildlife crossings in Utah. Adam Small, KSL NewsRadio.

Flashing beacons have been proven to be more effective at gaining drivers’ attention and reducing vehicular speed. These activated wildlife crossing signs are typically installed during seasonal migration periods and are equipped with flashing lights to attract driver’s

attention. Activated signs can use infrared technology to detect approaching wildlife, which will trigger the flashing lights,³⁶ or the lights can be set to remain flashing for a set period of time. A study conducted by the Insurance Institute for Highway Safety found that flashing beacon signs reduced speed by 8 mph, and that DVCs were reduced by 70% during migration.³⁷ The NCDOT Division Traffic Engineer should be contacted when requesting flashing beacons.

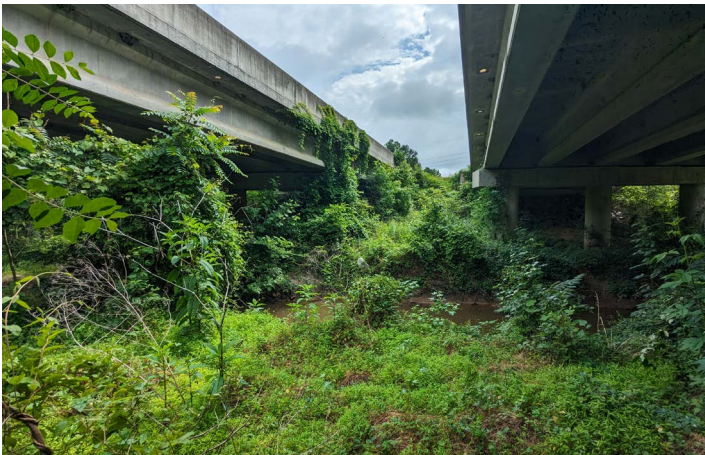
Vegetation under the bridge does not appear to be an obstacle, but vegetation downstream along the streambanks is dense, brushy, and thorny. There are also abundant invasive woody species present which should be removed, as they significantly degrade the habitat value of the corridor through the ROW. Vegetation management in at least the downstream riparian area should be explored to determine if it would help guide or attract wildlife to the riparian corridor and the crossing under the bridge. If these aspects are addressed, this crossing site may be a good candidate for fencing, depending on parcel ownership, fencing design factors, etc.

Facing east, under US 15-501 bridge at Pokeberry Creek. DCHC MPO.

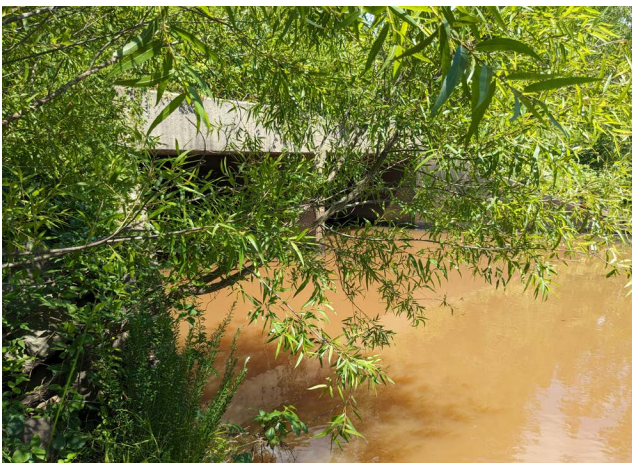
Several elements of the roadway embankment (causeway) and stream culvert construction present challenges for the potential of dry passage through the culvert except potentially in times of extremely low water levels when no standing water is present. First, the culverts are not wide enough to accommodate dry wildlife passage and hydrology. Further, the placement of embankment riprap slope protection to the toe of the embankment at the adjacent floodplain elevation, cuts off dry passage from the floodplain when it is flooded. In addition, the uniform steep slope of the riprap on the embankments and the concrete wingwalls does not include a level bench that could be tied into the culvert if dry passage through them were provided.

Facing East from west side of Big Woods Road culvert. Pete Schubert.

Construct new dry culverts through the causeway as wildlife underpasses on both sides of the existing culvert, placed so that wildlife can move from dry habitat areas on either side of the road, through these new dry culverts, to dry habitat areas on the other side of the road. These two new culverts should be at least 8 feet high and 12 feet wide, with a natural surface floor that is not normally flooded and should be straight with no offset or skew. If sufficient causeway height is not present to achieve the required height of the new dry culverts, the profile of the roadway may need to be raised in the section between the new culverts.

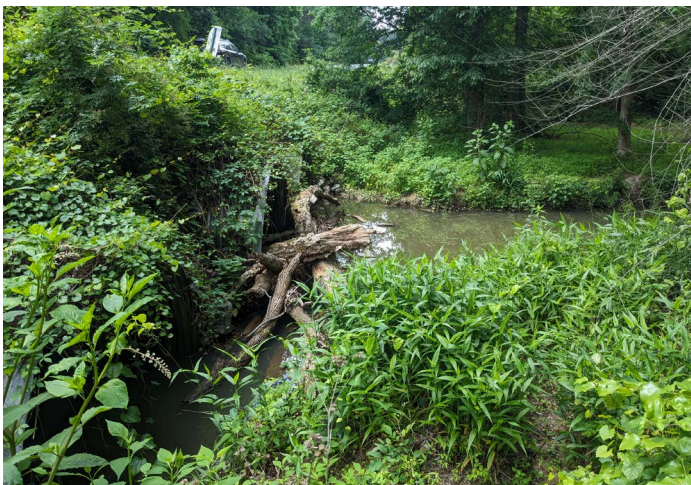
Barriers to wildlife travel exist along this corridor and through the culvert, which encourages wildlife travel on the roadway and results in conflicts with motorists. This site offers no dry passage for wildlife through the existing triple pipe culvert. During the relatively low water conditions on the date of site assessment, all pipe culverts were flooded with water, and debris was blocking the central culvert pipe. The three identical pipe culverts are round corrugated galvanized steel (pipe appears to be bituminous-coated on bottom) and are aging. Given the less than 6 feet of elevation difference between the road profile and the adjacent floodplain, there is no opportunity for any modification to the pipe culverts or installation of dry passage culverts adjacent to the existing culverts away from the stream channel.

East side of Manns Chapel Road culvert over Wilkinson Creek. DCHC MPO.

The existing triple pipe culvert could be replaced with a 5-bay box culvert that provides outer cells with higher, dry passage for wildlife on both sides of the stream, with these dry passages connected to habitat up and down stream; or, a relatively short, full open-span bridge wide enough and high enough for dry passage on both sides of stream. The road causeway profile should be raised sufficiently to provide at least 8 feet of vertical clearance between the natural surface bottoms and the box culvert ceilings within dry passage bays.

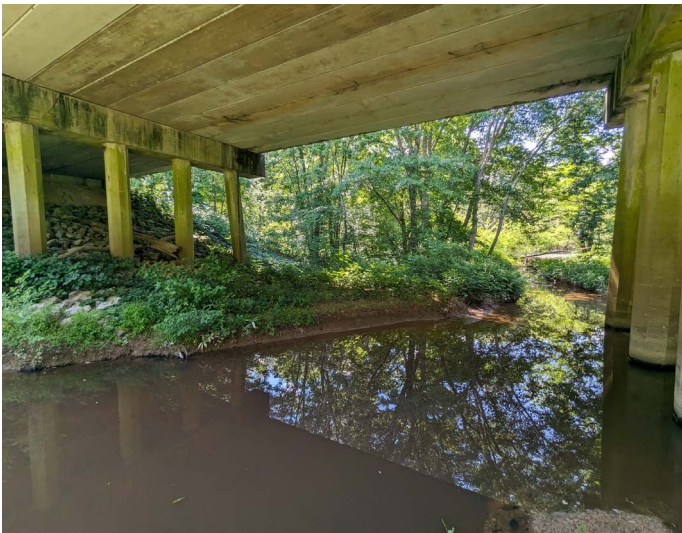
Barriers to wildlife travel exist along this corridor and under the bridge, which encourages wildlife travel on the roadway and results in conflicts with motorists. The continuous riprap slope protection along the causeway/roadway embankments and under the bridge is a major barrier to wildlife passage through the underpass and connection to habitat areas up and downstream. This riprap extends from about 10 feet below shoulder grade down to the toe of the slopes at the floodplain without a bench that could function as dry passage above the floodplain elevation. Though low water dry passage exists on the east side, none exists on the west side, and neither functions at high creek levels. A 30 feet wide partially dry natural surface floodplain exists on the north bank under the bridge, beyond the toe of the riprap slope protection that has good connectivity to adjacent up and downstream habitat, but only at low water levels. No dry passage is present on the south bank as the riprap slope protection extends to the top of the creek bank.

Under bridge at Jack Bennett Road over Herndon Creek, facing northwest. Pete Schubert.

Construct new dry culverts through the causeway to serve as wildlife underpasses on both sides of the existing bridge span, placed so that wildlife can move from dry habitat areas on either side of the road, through these new dry culverts, to dry habitat areas on the other side of the road. These two new culverts should be at least 8 feet high and 12 feet wide, with a natural surface floor that is not normally flooded, and be straight with no offset or skew. If sufficient causeway height is not present to achieve the required height of the new dry culverts, the profile of the roadway may need to be raised in the section between the new culverts.

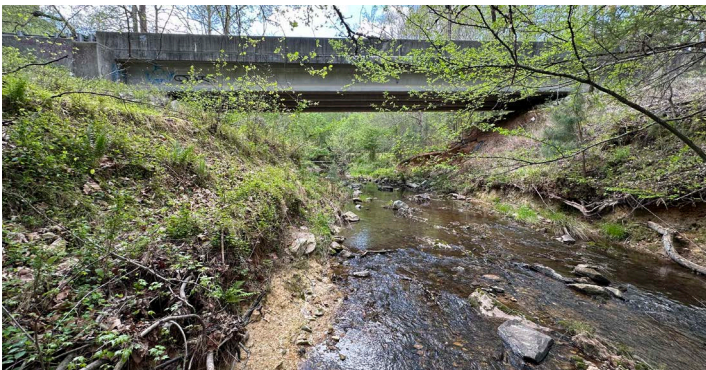
The slopes from the creek bank to the abutments appear to have been once covered by riprap slope protection, but all that remains is some riprap within a few feet of each abutment; the rest has been eroded away and the underlying subgrades have been significantly scoured away. These slopes should be rebuilt to provide natural surface dry passage benches, while also providing critical stabilization of the abutment slopes. The bridge appears to be a recent replacement span and of adequate span length to provide dry passage on both sides if the slopes are reconstructed and stabilized adequately.

Rivermont Road ridge over Nancy Rhodes Creek looking Southwest. DCHC MPO.

Evaluate and permanently repair deep erosion of banks due to stormwater flows coming from the roadway embankments and daylighting downstream of the bridge.

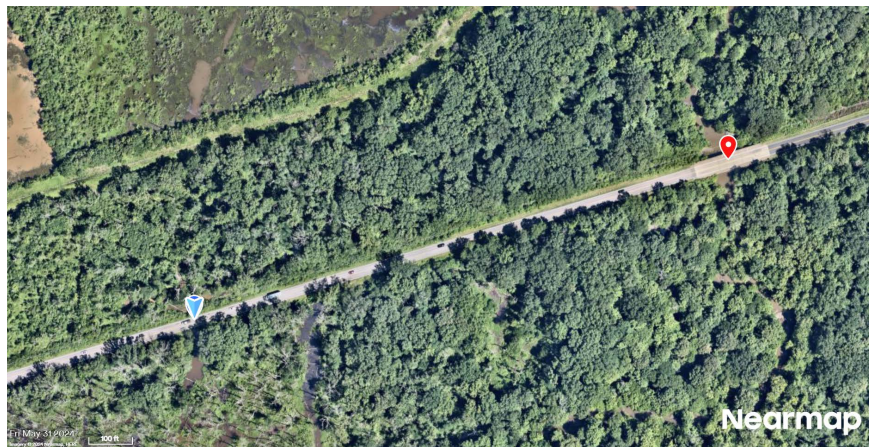
Approximately 500 feet upstream of NC 54 in the New Hope Creek floodplain is the New Hope Waterfowl Impoundment, which consists of two low (5-foot rise) earthen causeway/embankments (roughly 1,950 feet west and 250 feet east), connected by a 490-foot flat topped concrete spillway and a 2-bay stoplog control structure across the creek channel. Immediately downstream and parallel to the spillway and outlet structure is a 490-foot by 130-foot open water stilling basin, which provides a significant barrier to wildlife passage along the creek up and downstream, forcing movement away from the banks to cross the sub-impoundment structures, and then to return to the narrowed banks approaching the NC 54 bridge and causeway. Additionally, when seasonally impounded (fall/early winter), terrestrial wildlife passage is forced to the far edges of the inundated floodplain. Though the grassed, low slope sub-impoundment embankments are not significant barriers, the NC 54 embankment and motor vehicle traffic is. Additional dry culverts should be added to NC 54 at the causeway ends to allow for dry passage of wildlife when the impoundments above and/or below NC 54 are flooded.

Aerial photograph of NC 54 culvert (west) and bridge (east) over New Hope Creek. Nearmap.

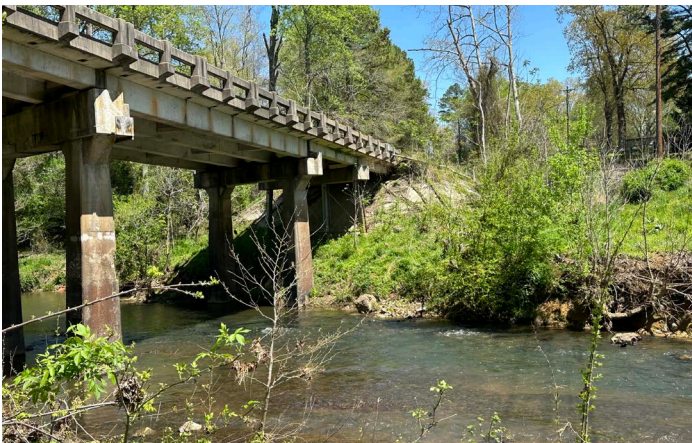
Barriers to wildlife travel within this core and under the bridge exist, which encourages wildlife travel on the roadway and results in conflicts with motorists. Current site conditions show that while the bench on the west side is serving as both wildlife passage and the MST alignment, the east side of the bridge is not conducive to wildlife movement due to the steep concrete slope and moderately steep natural surface embankment with no functional bench. Note that the master plan for continuation of the MST to the north (upstream) has the MST crossing the Eno River on or adjacent to the Pleasant Green Road bridge. As such, the new bridge must include enough new bend on the river's east side to accommodate wildlife passage and trail passage needed once the MST is open on the east side. The east side is presently used by fisherfolk to access bank fishing, which is likely to continue.

Pleasant Green Road bridge over Eno River facing East. DCHC MPO.

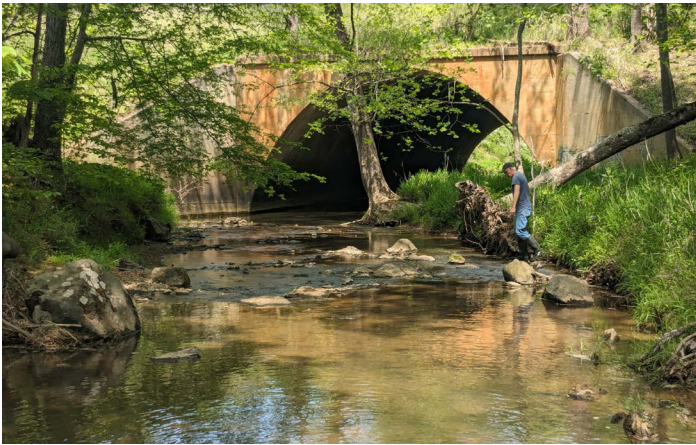
Barriers to wildlife travel through the culvert exist, which encourages wildlife travel on the roadway and results in conflicts with motorists. This site does provide dry passage (approximately 25 feet) on the east side of the stream during low water conditions. However, there is no dry passage on the west side of stream, and the stream bank leading up to the culvert on the west side is extremely steep. As a result, wildlife will be forced around the steep stream bank (and the concrete wingwall extending from the culvert inlet) and up the road embankment to the roadway. However, the stream channel itself is narrow, shallow, and slow enough (at least during the low water conditions) that many wildlife species would be able to cross the stream to dry passage on the east side. During times of high and fast water flow, wildlife would be prevented from crossing the stream and could attempt to cross on the roadway.

I-85 culvert over Stony Creek, facing north, downstream. Pete Schubert.

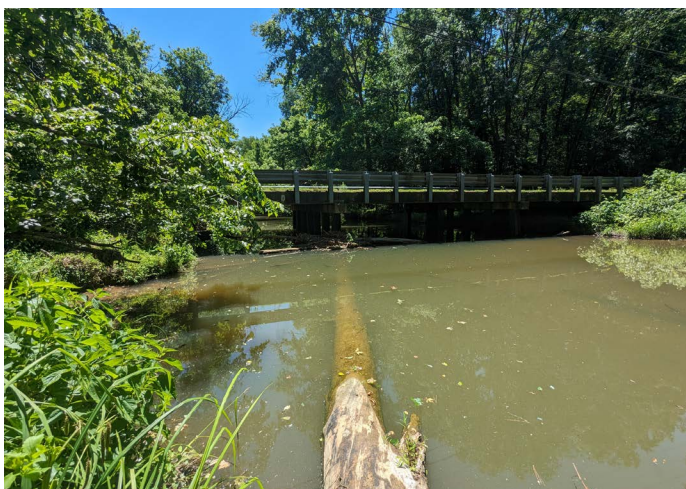
Barriers to wildlife travel along this corridor and under the bridge exist, which encourages wildlife travel on the roadway and results in conflicts with motorists. The barriers include standing water, riprap, and low visibility. Standing water is present just outside of the bridge underpass area and extends into habitat areas that are in the direct path for wildlife toward the dry underpass. The low visibility of the passage area under the bridge is caused by dense vegetation near openings and (possibly) the metal wings extending from the ends of bridge.

East side of Jones Ferry Road bridge over Neville Creek. Pete Schubert.

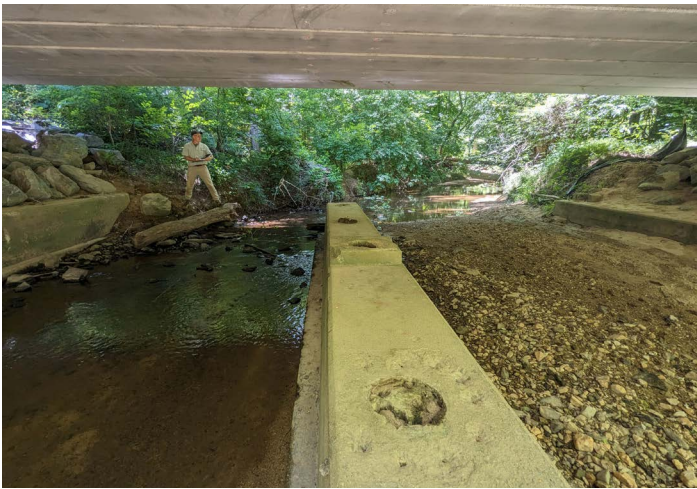
Barriers to wildlife travel along this corridor and under the bridge exist, which encourages wildlife travel on the roadway and results in conflicts with motorists. The bridge at this site was replaced within the past few years. While the footings for the previous bridge were left in place to minimize disturbance to the creek channel, they are constraining the flow and some wildlife access to the creek under the bridge. However, the outer footings stabilize the low-slope abutment embankment toes, providing considerable space for dry wildlife passage. But such passage is not possible due to the placement of exposed, oversize riprap. Given the low slope, the riprap could be removed, but the sheer size of the riprap and the low overhead clearance makes heavy equipment access difficult. If the riprap can be relocated or removed to expose a natural surface, it can be left in place with the voids filled with fine aggregate and alluvial materials to create a natural surface at all points with at least 4-feet of vertical clearance to the deck bottom above. Under the bridge, there is ephemeral dry passage through only the north channel, and only at low flow. At higher flows, both channels have standing water and there is no dry passage due to the riprap slope lining on both sides, except on the narrow (one-foot wide) flat footing tops.

Under Neville Road bridge over Phil's Creek, facing East. Pete Schubert.

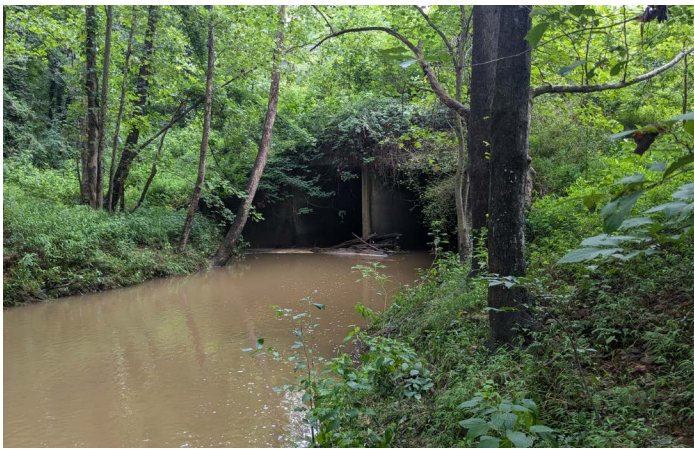
North side of NC 54 culvert, facing South.
Pete Schubert.

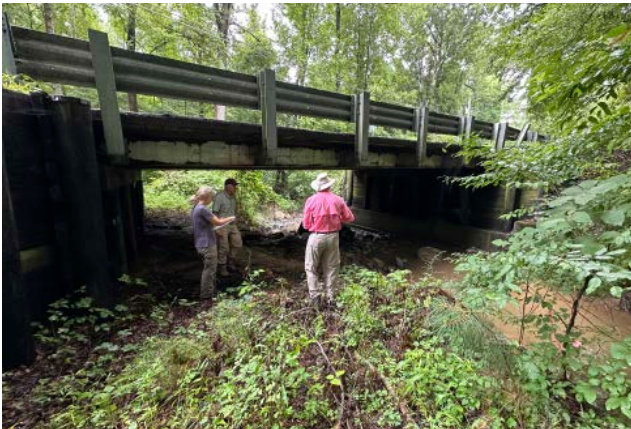
West side of Damascus Church Road bridge over Pritchard Mill Creek, facing east. DCHC MPO.

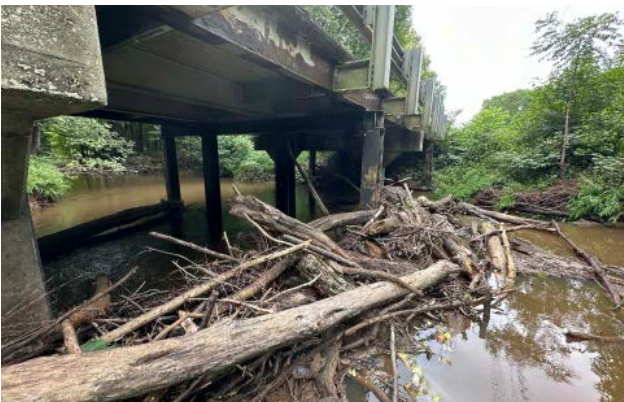
West side of NC 86 bridge over New Hope Creek, facing east. DCHC MPO.
